A LEACHATE RECOVERY SYSTEM  
AT THE PREMIER STREET LANDFILL,  
NORTH VANCOUVER, BRITISH COLUMBIA

Golder Associates, Vancouver, B.C.

This paper presents a case history involving the containment and control of leachate emanating from the Premier Street Landfill in North Vancouver.

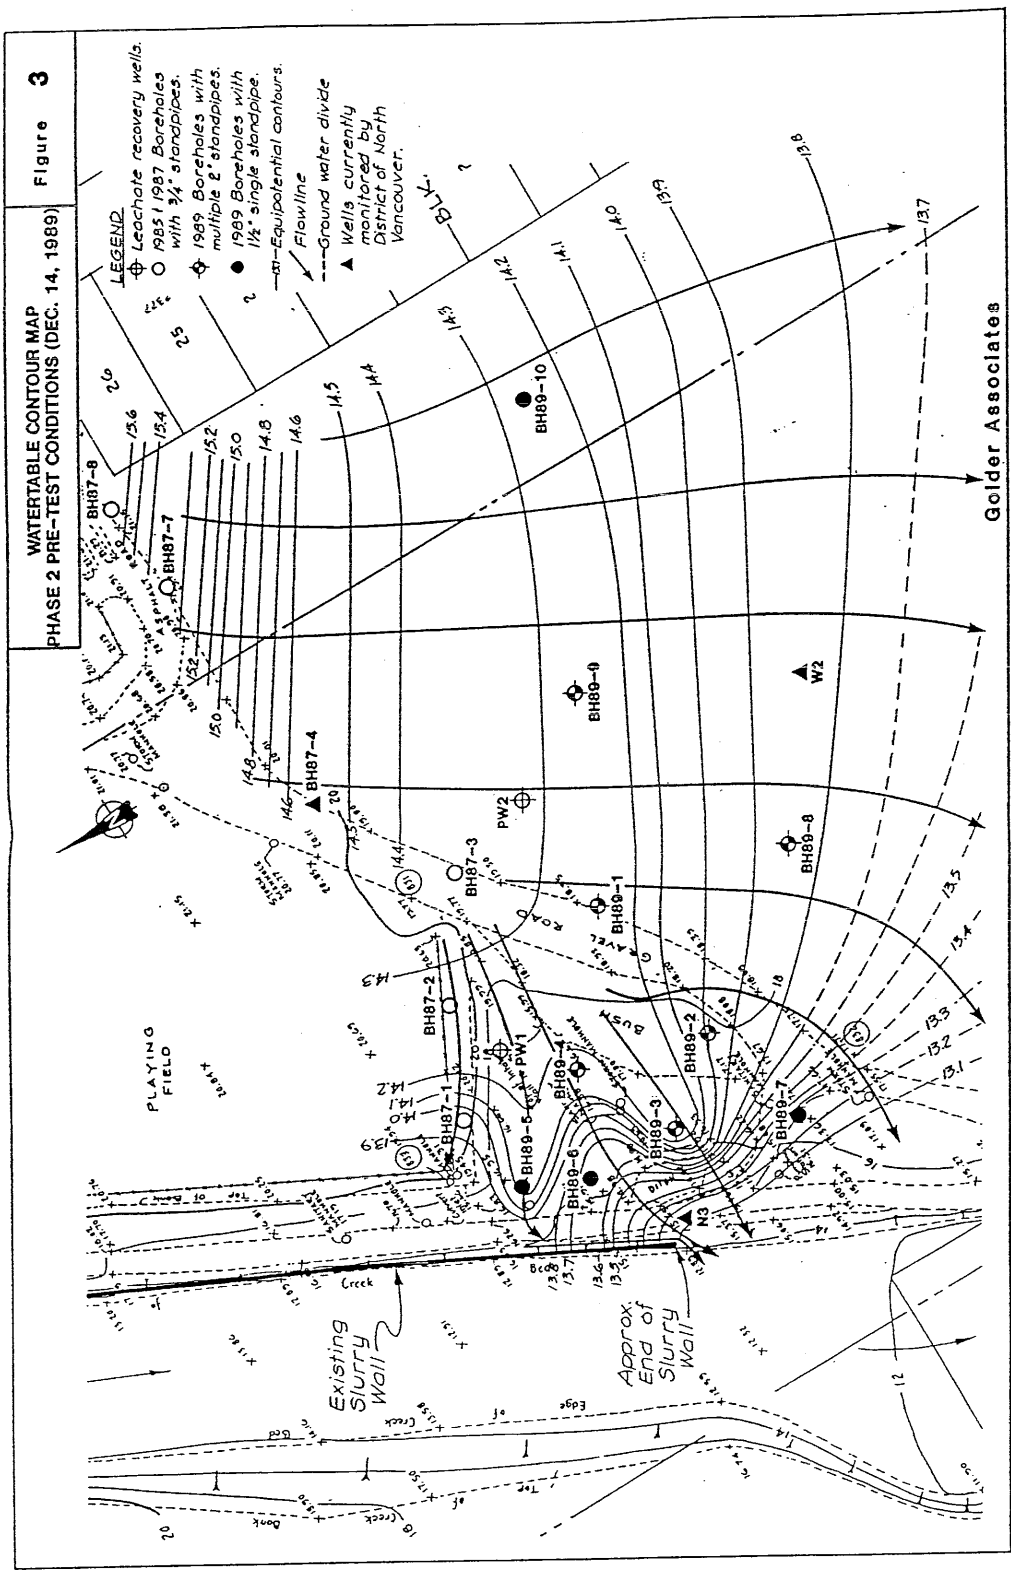
Figure 3 is a contour map of the water table, measured December 14, 1989, in the area immediately to the south of the "old" landfill. The contours in Figure 3 represent lines of equal hydraulic potential. Perpendicular to these equipotential lines, flowlines have been sketched in showing the direction of groundwater flow. Ground water migrates toward Lynn Creek with the steepest gradients occurring at the edge of the existing slurry wall. This plot also shows ground water just below the playing field moving toward the current leachate drainage system.

During the initial Phase 1 work, four 8" diameter boreholes were drilled (BH 89-1 to BH 89-4). The location of these boreholes is shown on Figure 3. These holes were drilled to fill in gaps between an existing set of monitoring wells which were installed as part of earlier investigations. Multiple 2" diameter piezometers were installed in each of the boreholes, with the deepest piezometer located at the base of the aquifer, at the contact with the till surface. Each piezometer consists of a 3.3 m (10 ft.) length of screen, sand-packed along its length with a clean silica sand. Above the screen and sand-pack, a bentonite seal was placed in order to isolate each piezometer from adjacent piezometers, and allow the sampling of organic and inorganic constituents from discrete horizons within the aquifer.

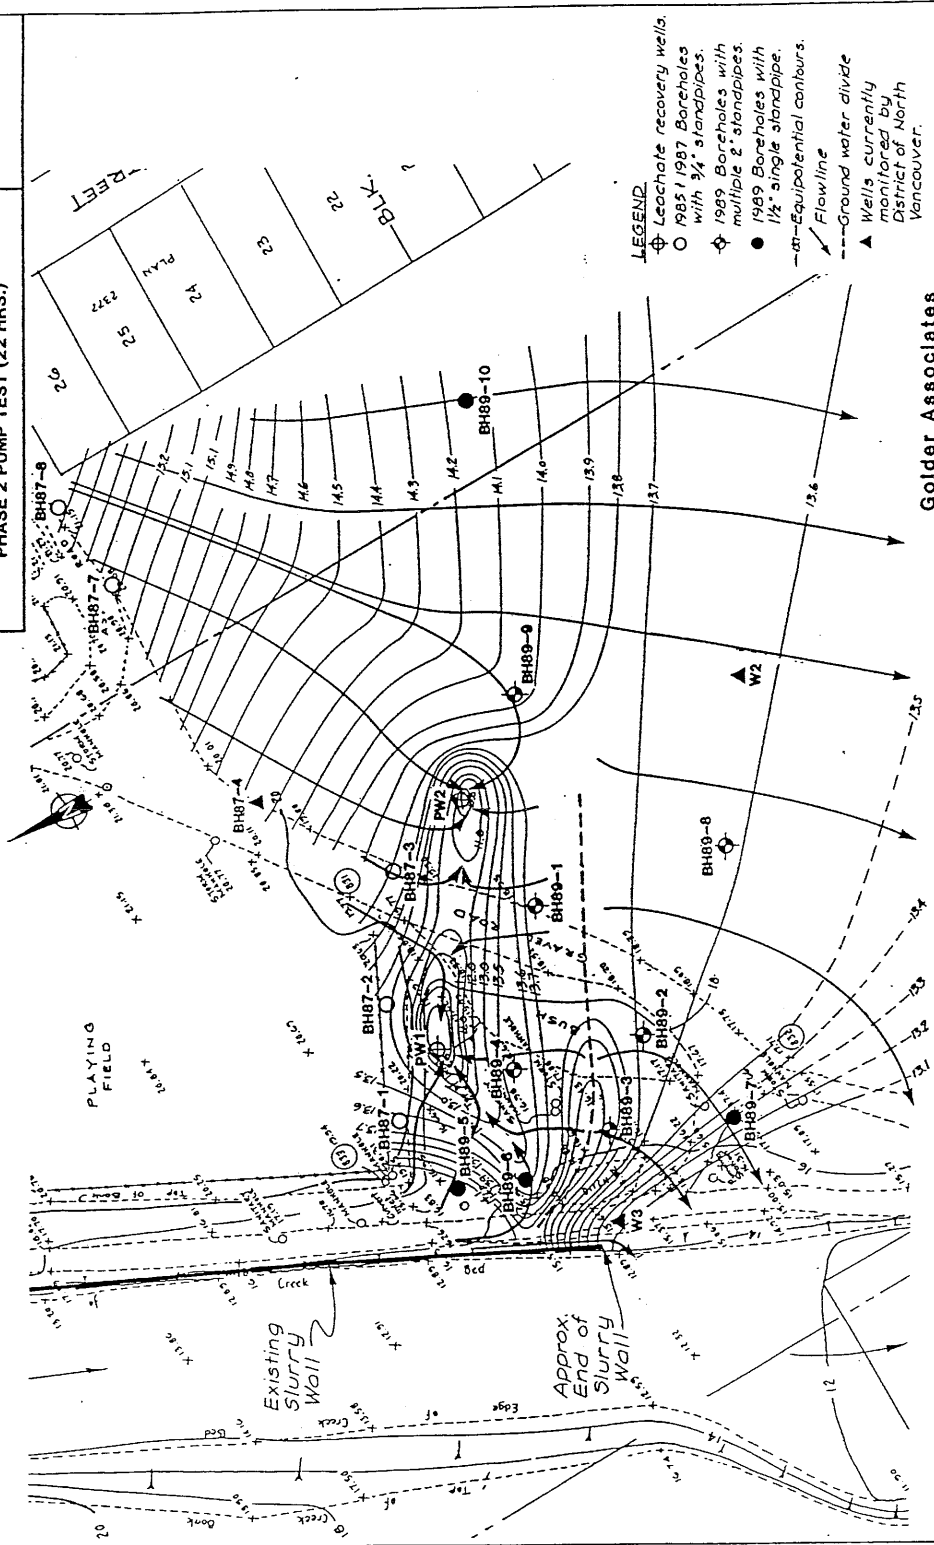
The pump test ran for 24 hours. P.W.1 was pumped at 88 USgpm and P.W.2 at 45 USgpm, making the total discharge 133 USgpm. The water pumped during this test was discharged to the sanitary sewer at the Pumping Station. Figure 4 is a contour plot of the water table after 22 hours of pumping. As can be seen from the figure, pumping of both recovery wells creates a steep cone of depression such that ground water flowing towards the southwest, from the corner of the landfill where the current municipal yard is located, is captured by P.W.2. Leachate originating from the waste situated below the playing fields is also captured by the recovery wells, as is the majority of leachate which is flowing along the existing slurry wall. Figure 4 is the most conservative plot (i.e., the worst case scenario) of pump test data and shows that a very small amount of leachate may still have been migrating in a narrow zone along the slurry wall at the conclusion of the pump test.

Figure 4 shows that P.W.1 and P.W.2 are successful in capturing the majority of the flow emanating from the landfill. The amount of leachate which may have been migrating along the edge of the slurry wall and by-passing the recovery wells is small, and will likely be captured once long-term pumping is underway and steady-state flow conditions are achieved.

The nature of the flow regime in the vicinity of the slurry wall will be closely monitored during the Phase 3 long-term monitoring program to determine whether or not leachate is bypassing the recovery wells. Should it be determined during the long-term monitoring program that migration of leachate along the slurry wall is occurring, and if the amount is deemed to be significant enough to cause staining along the creek, installation of a third recovery well may be considered.
