TWITCHELL ISLAND LEVEE IMPROVEMENTS, NORTHERN CALIFORNIA DELTA AREA

Richard C. Sisson¹ and Fred N. Brovold²

Abstract

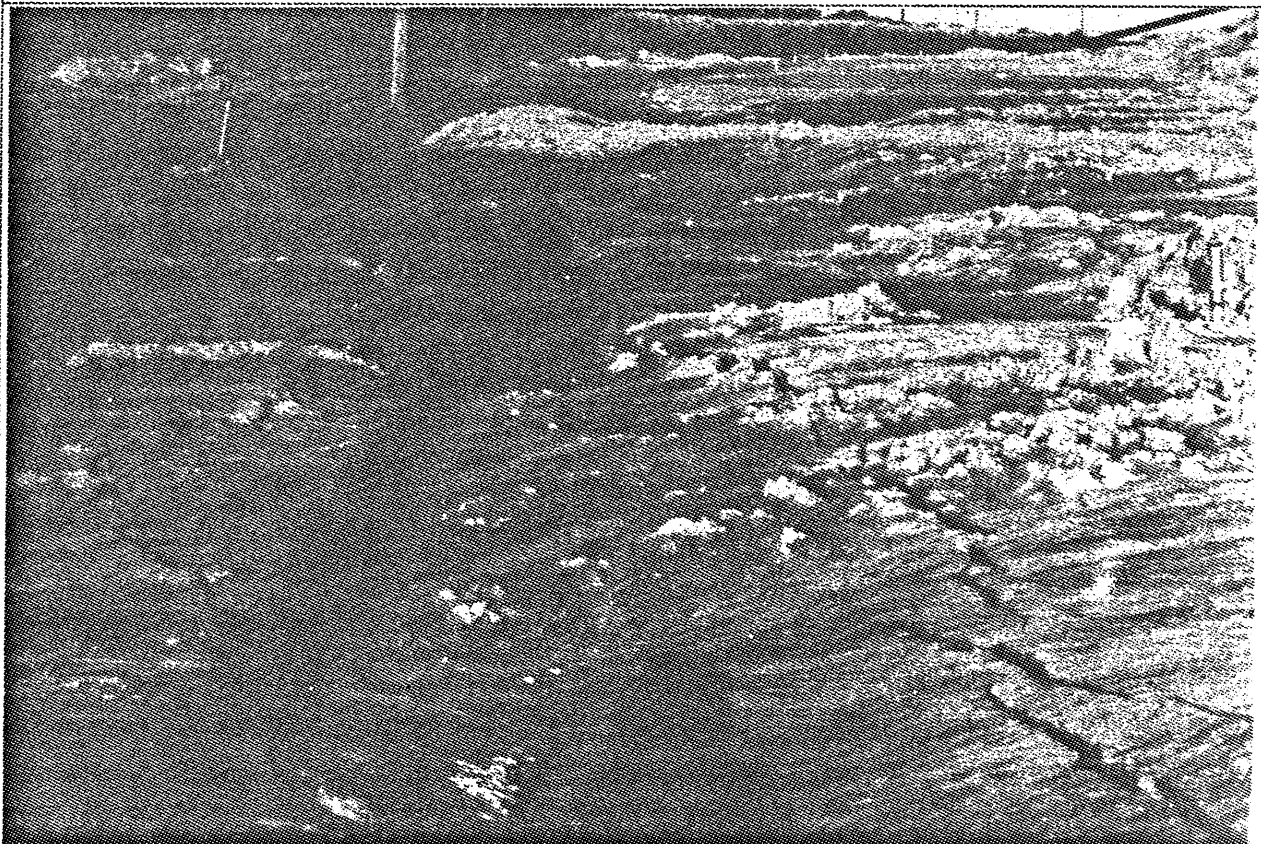
Figure 13 -Cracking on Berm

Berm: In some locations, cracks were observed along the new berm. These cracks often exhibited several inches of vertical offset (see Figure 13). Frequently, the cracks were parallel with opposing vertical offset leaving grabens between the cracks. These cracks may be caused by lateral displacement of peat below the berm, or may be effects of old drainage ditches.

In most instances, the most serious risk from cracks that occurred are believed to be the possibility of water flowing into the cracks and resulting in further deformation due to increased hydrostatic pressure. Cracks in the berm often were regraded after the fill settled, or they were covered with the second lift of fill. Cracks on the levee backslope were fine graded and track-walked. Some cracked areas on the levee crown were overexcavated and backfilled to reduce the potential for the cracks acting as a preferential seepage path.

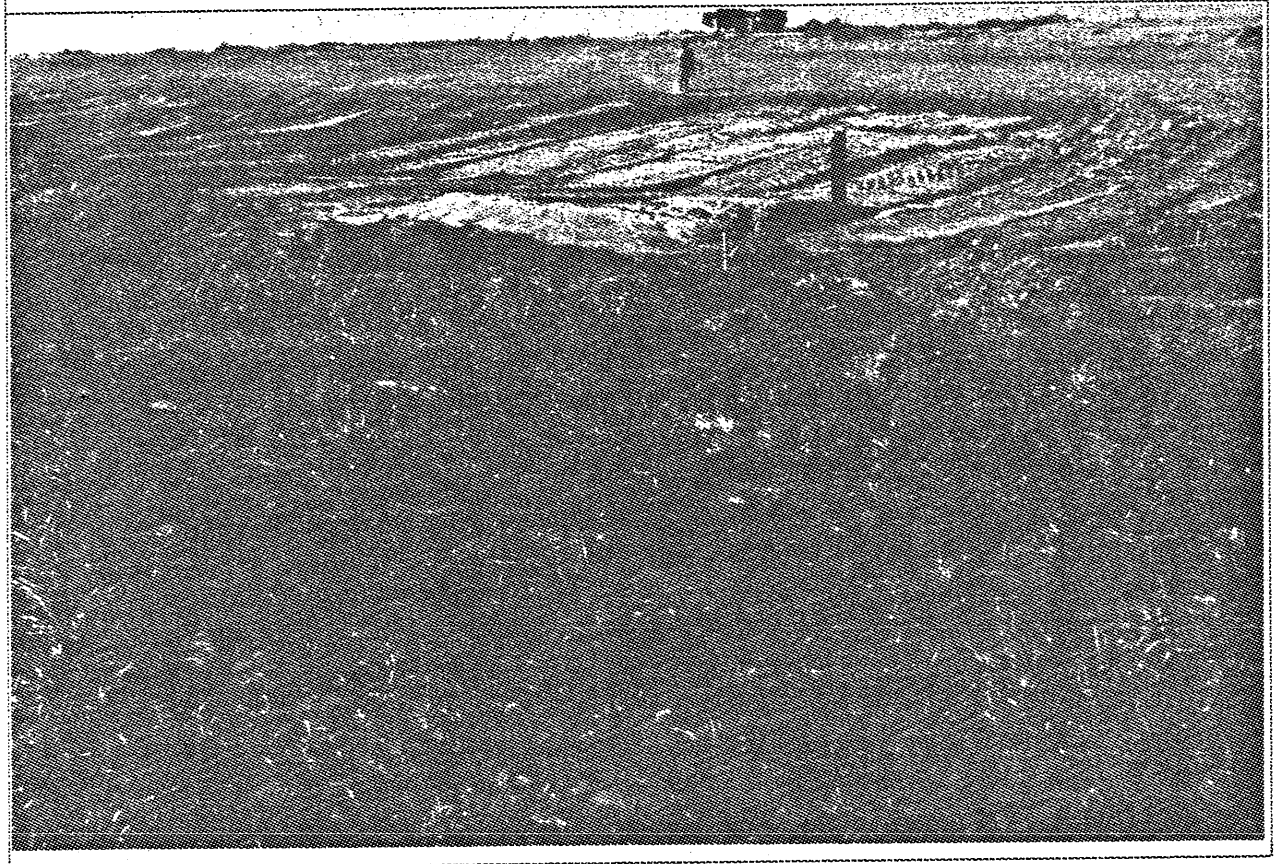
Figure 14 - Cracking Landward of Berm

Island Areas Beyond Berm: In two instances, tensile cracks were observed to

propagate more than 10 m landward of the berm at an angle of about 45 degrees to the berm alignment (See Figure 14). The cracks were on the order of 300 mm wide, and depths of nearly 3 m were measured. Soil blocks in the middle of the cracks were down-thrown, similar to the grabens described previously. The contractor reported observing one crack propagate rapidly, about 30 m ahead of the fill placement.

These cracks are believed to represent three dimensional effects of berm deformations. The cracks may be the lateral boundary of a soil block landward of the berm that experiences large, rapid lateral displacement during berm placement. The large vertical displacements occurring beneath the berm may have also contributed to the cracking. The cracks did not appear to threaten the levee or berm, but were backfilled for safety reasons.

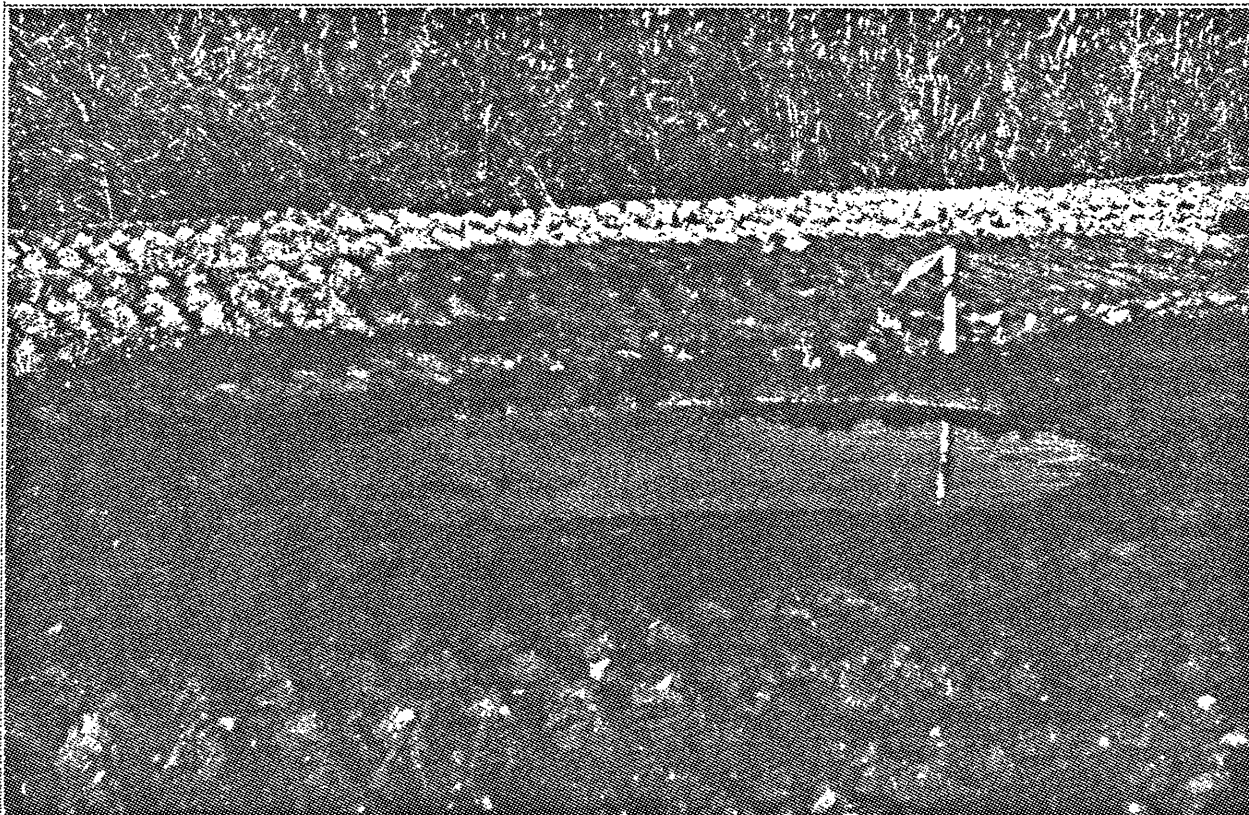
Figure 15 - Subsidence Feature

Subsidence features are defined in this paper as deformations that have large vertical components relative to lateral components. They appeared on the site as either deep circular depressions (sink holes) or linear depressions as long as 300 m (see figure 15). Soundings indicated that these depressions were over 3 m deep. It is believed that the depressions result from an upper layer of fill flowing into underlying cracks in

the peat. Such cracks could result from lateral displacement at the base of the peat. Some subsidence features could be the result of other phenomena, but most features at Twitchell Island would fit this hypothesis.

Subsidence features were filled with either sand or gravel fill. Following the lateral spreading fissure theory, placing fill in these features could cause the fissure to widen. In fact, small features often required several truck loads of material to fill them. In some cases, it appeared helpful to wait several days prior to backfilling or to place the backfill in stages. It may be that this allowed dissipation of excess pore pressures.

However, these depressions sometimes reappeared, particularly when additional fill for the second berm lift was placed.
