# **FOUNDATION CONSIDERATIONS AT TAR ISLAND DYKE**

**AGRA Earth & Environmental Limited**

**Vancouver Geotechnical Society  
Construction on Peat and Soft Soils  
9th Annual Symposium**

**June 2, 1995**

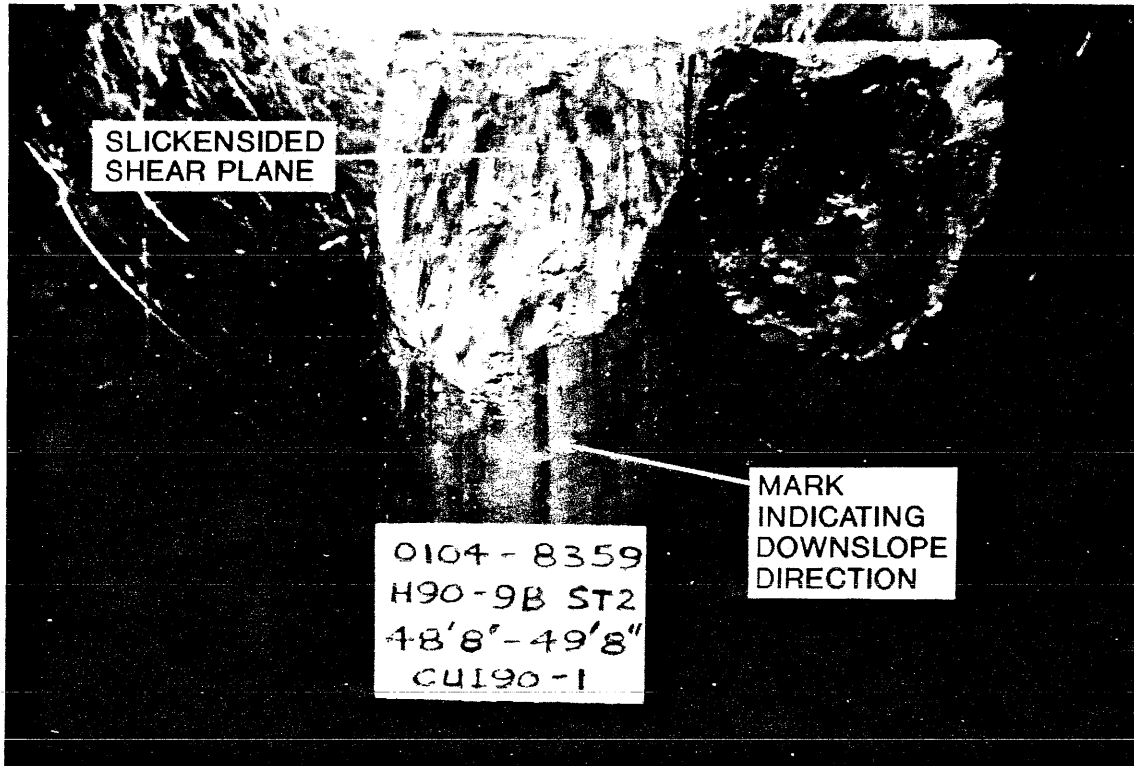
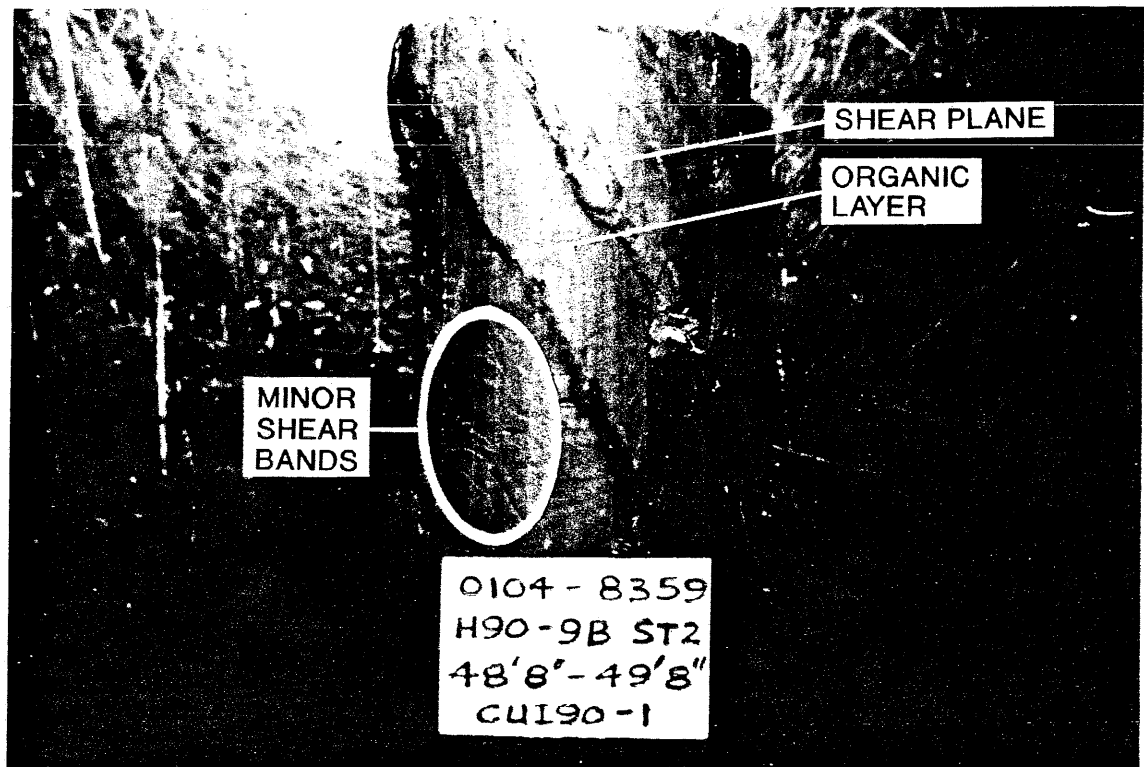
Figure 13. Photo of Inclined Sample

Four triaxial tests, two drained and two undrained, were conducted on inclined specimens obtained from 6" diameter, 18" long thin walled sampling tubes. The downstream direction was constantly tracked and marked on the tubes and on the samples so the direction of shearing in the field could be continued in the lab. The samples were inclined at  $45 + \phi/2$  degrees to the horizontal so that failure could take place parallel to the bedding. The other option of failure across bedding was also available to the sample. Figure 13 provides photographs of one of the inclined samples after shearing.

The two CUP test samples failed along bedding surfaces and in fact the shear planes protruded through the top of the samples indicating that they had developed along planes of weakness. The shear surfaces after testing were slickensided and wavy. Examination

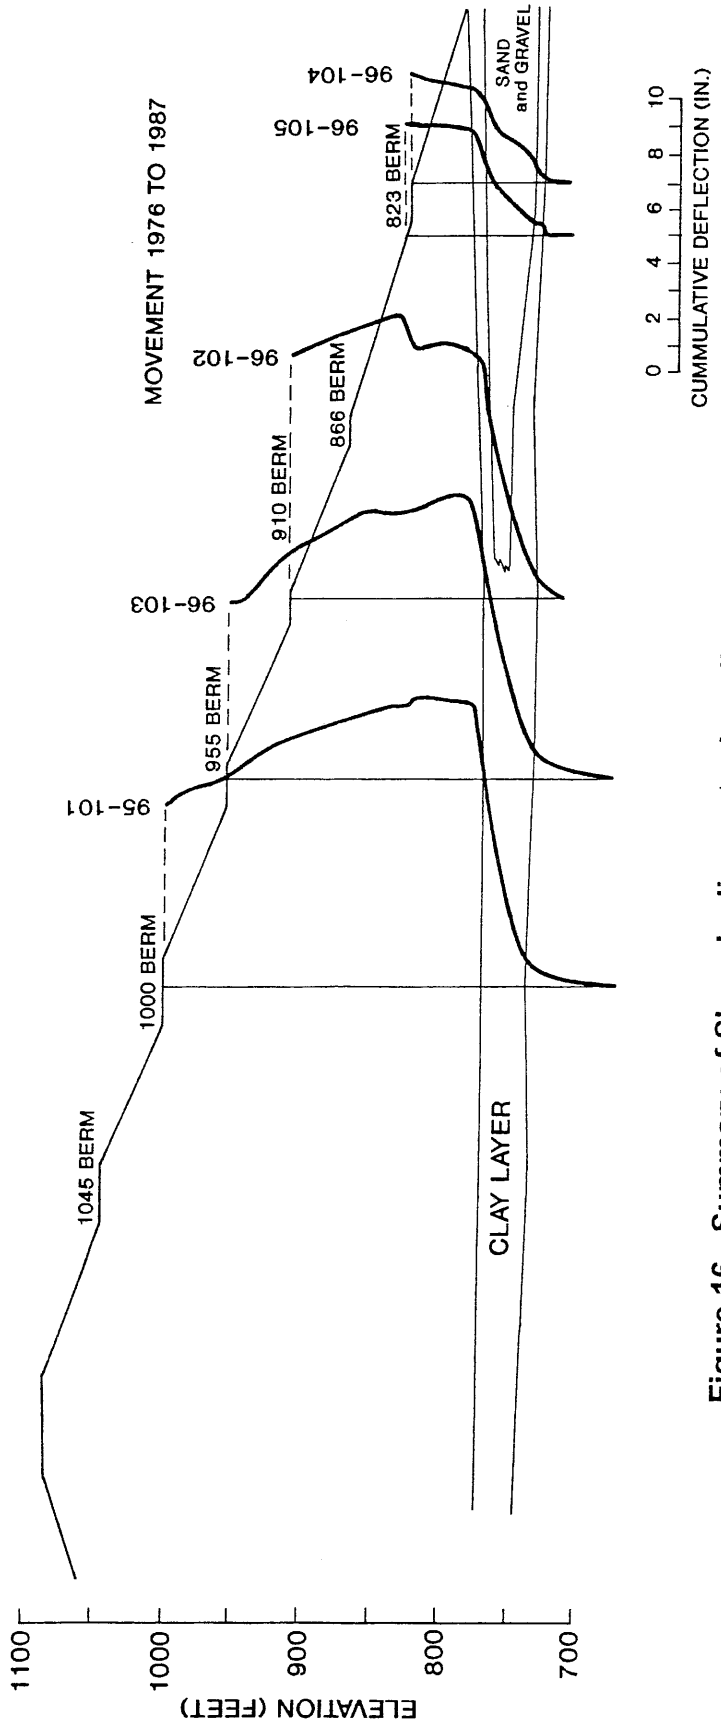
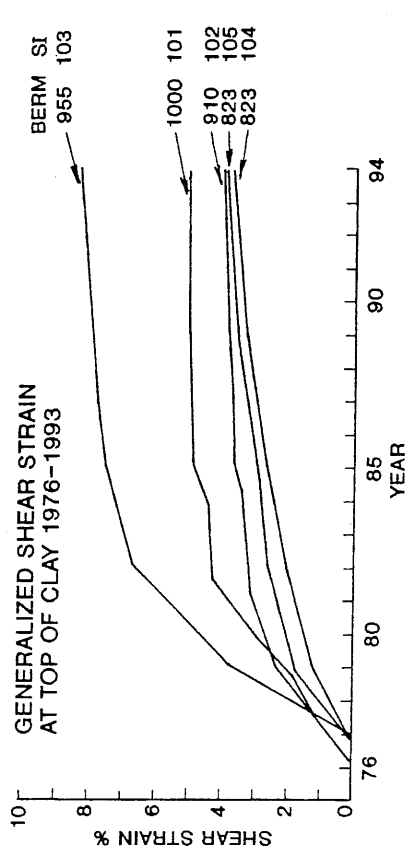
Figure 16. Summary of Slope Inclinometer Installed in 1976

As can be seen on Figure 16, the majority of horizontal movement has been in the foundation clay. The movement pattern indicates shear straining in the clay and no localized shear surface. This is consistent with the absence of a continuous slickensided layer or zone in the foundation clay as determined by the field investigation programs.

- Total horizontal movements are greater in the thicker clay upstream of the 910 Berm.
- Maximum shear strain rates in the earlier years recorded in Table 7 tended to be in the middle of the clay consistent with the zones of highest pore pressure.
- Maximum shear strain rates now are highest at the top of the foundation clay unit.
- Shear strain rates are tending to reduce and in some cases have approached zero.
- Of some interest is the backtilting observed in some inclinometers upstream of 910 Berm, see Figures 16 and 17. This movement pattern is discussed subsequently.

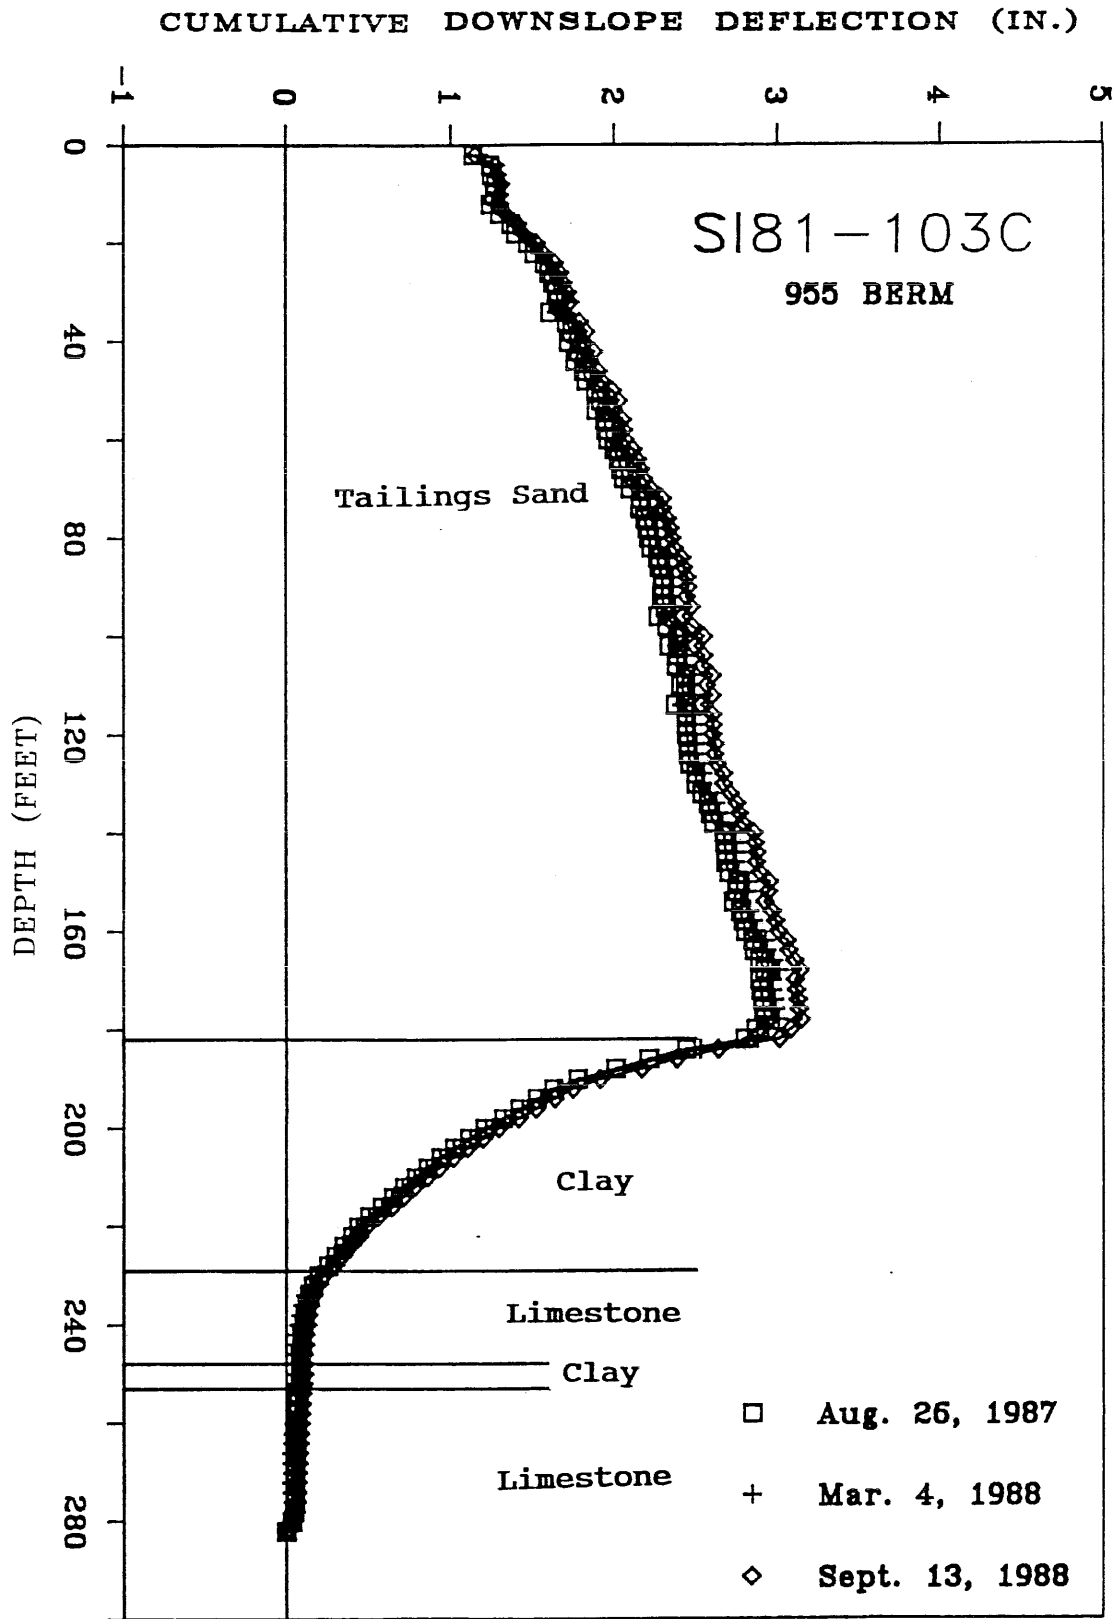
Figure 17. Slope Inclinometer SI81-103C

Superimposed on this effect is settlement. In the thicker deposits upstream of the 910 Berm, there will have been considerable settlement both of a primary and secondary (i.e.,  $K_\alpha$  drained creep) nature. These settlements will not be solely vertical because they are caused by principal stresses which were both increasing and rotating as construction proceeded. For a vertically installed inclinometer, these movements will appear as

downslope deformations and this mechanism is considered to be a dominant influence in the deeper channel infills. This mechanism also explains the backtilting observed in Figure 17, and the relative proportions of creep to total predicted strains in Figure 20. Figure 20 illustrates the relative components of the deformation, as measured by shear strain at specific depths, between total and creep related deformation. It can be seen that the relative amount of deformation due to creep versus settlement varies as one proceeds upstream from the toe. These patterns are reasonable when one considers the relative proportion of clay upstream and downstream of the 910 berm which, as was previously discussed, is at about the interface between the thinner overbank soils and the thicker channel infills.

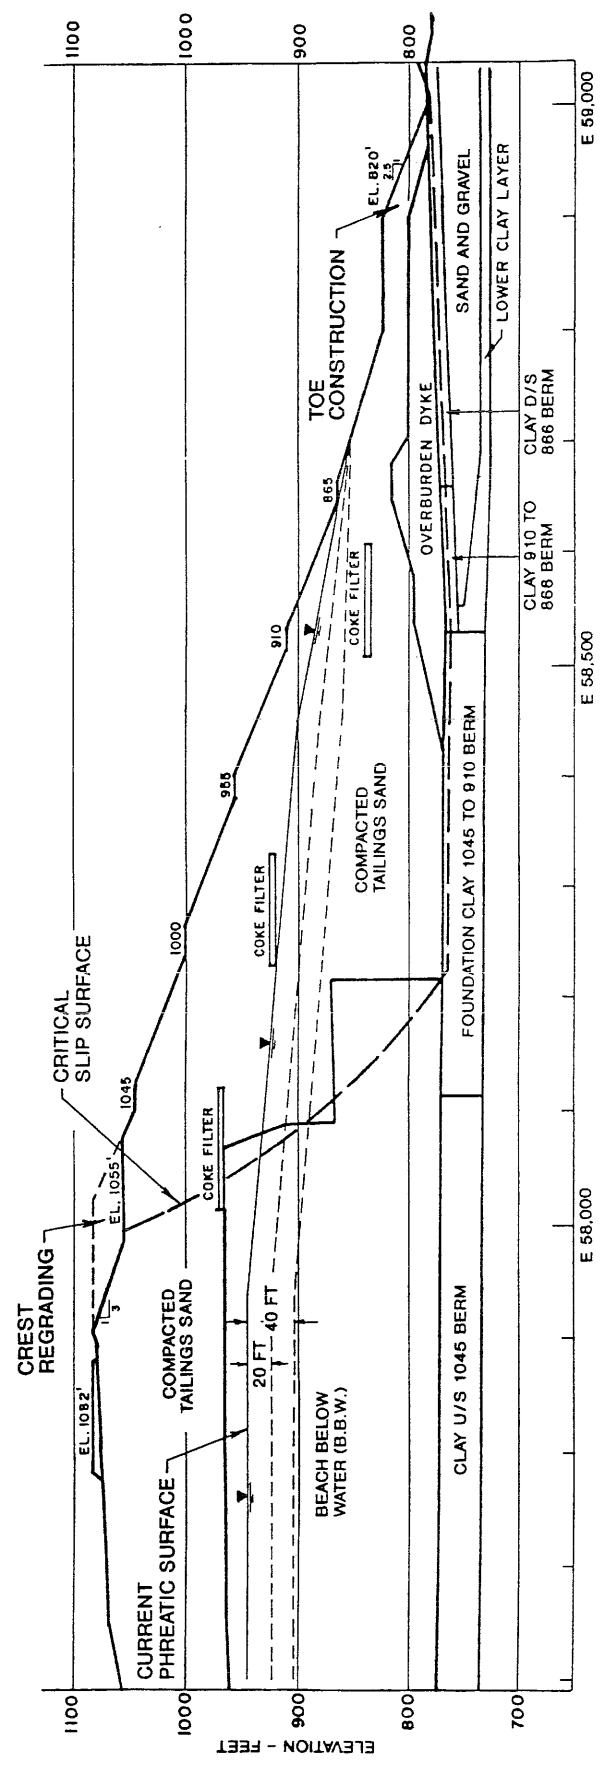
Figure 19. Example of Slope Stability Calculations at Critical Section

On this basis and as reported in Table 8 the design operational factor of safety was now assessed to be as low as 1.21, and 1.13 for the design case using full residual angles. The actual factor of safety was considered to be somewhere between the original peak strength basis of over 1.6 (as pore pressures were continually dropping) and the operational basis of 1.2 (Table 8). It was considered that the cost of determining the exact nature of the foundation to refine the factor of safety in more definitive terms would be excessive and even for such a program some uncertainty might still remain. As heavy equipment was available within the mine, the cost of mitigative action was reasonable and the latter course was recommended and adopted.

After considering several alternatives, it was decided to place a modest berm along the toe of the critical section and cut back the crest slightly. The material excavated from the crest was placed at the toe. The berm and crest excavation were designed in two phases with a re-assessment of conditions and performance at the end of the first phase. The response of the first phase indicated acceptable performance and the second phase was eliminated.
