Remediating the inactive Blackfoot Landfill

Chris R. Daniel

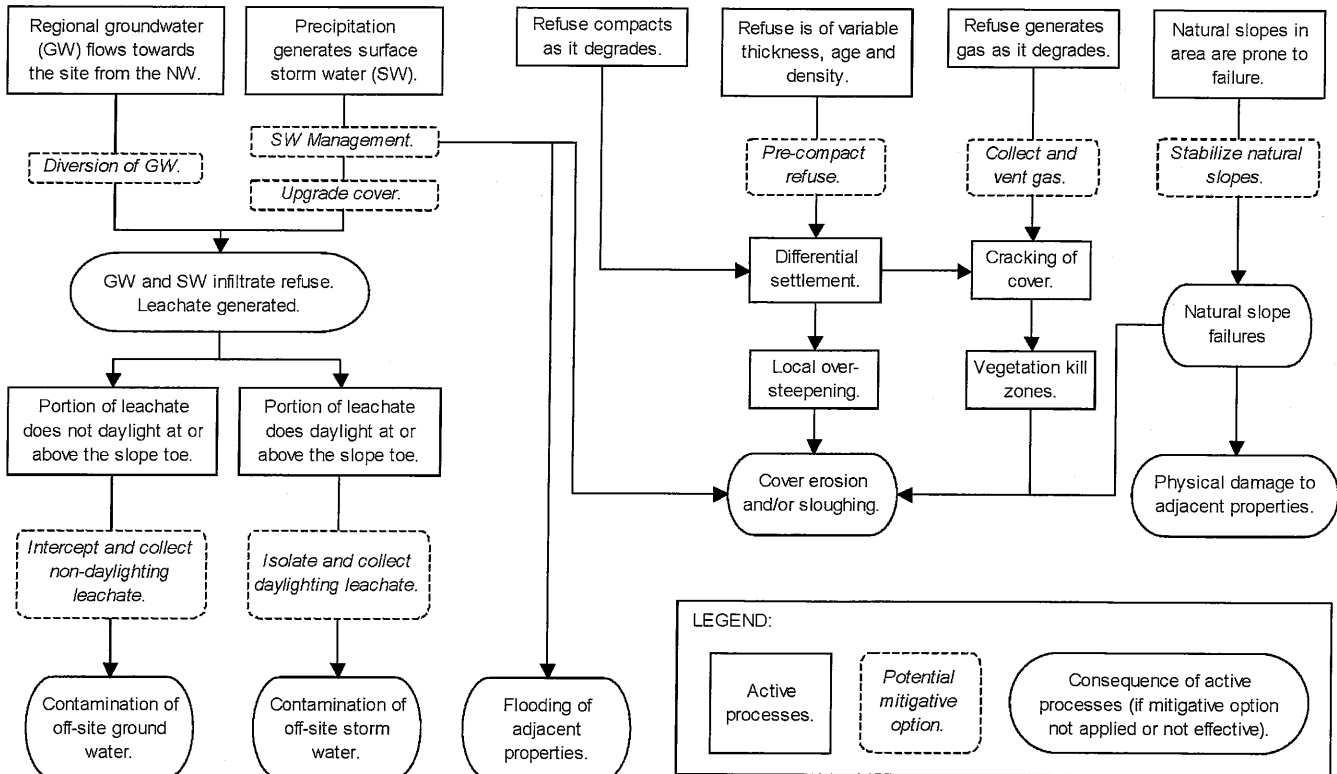
- diverting groundwater upstream of the site,
- effective management of storm water,
- collection of leachate daylighting at or above the toe of the slope,
- collection of contaminated groundwater at the toe of the slope,
- pre-compaction of refuse to avoid excessive differential settlement (e.g. by means of dynamic compaction),
- collecting and venting landfill gas, and,
- stabilizing natural slopes.

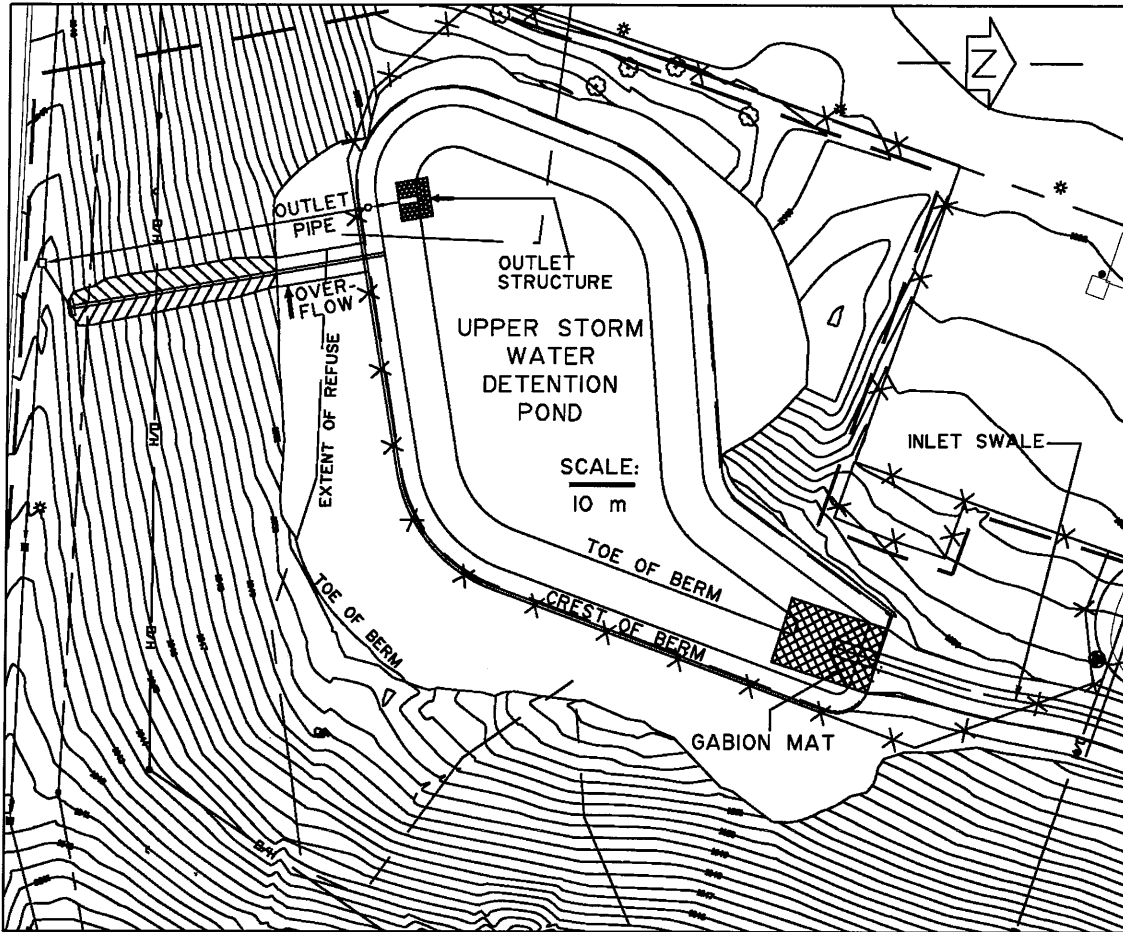
Fig. 5. Typical detail of Blackfoot Landfill upper storm water detention pond liner.

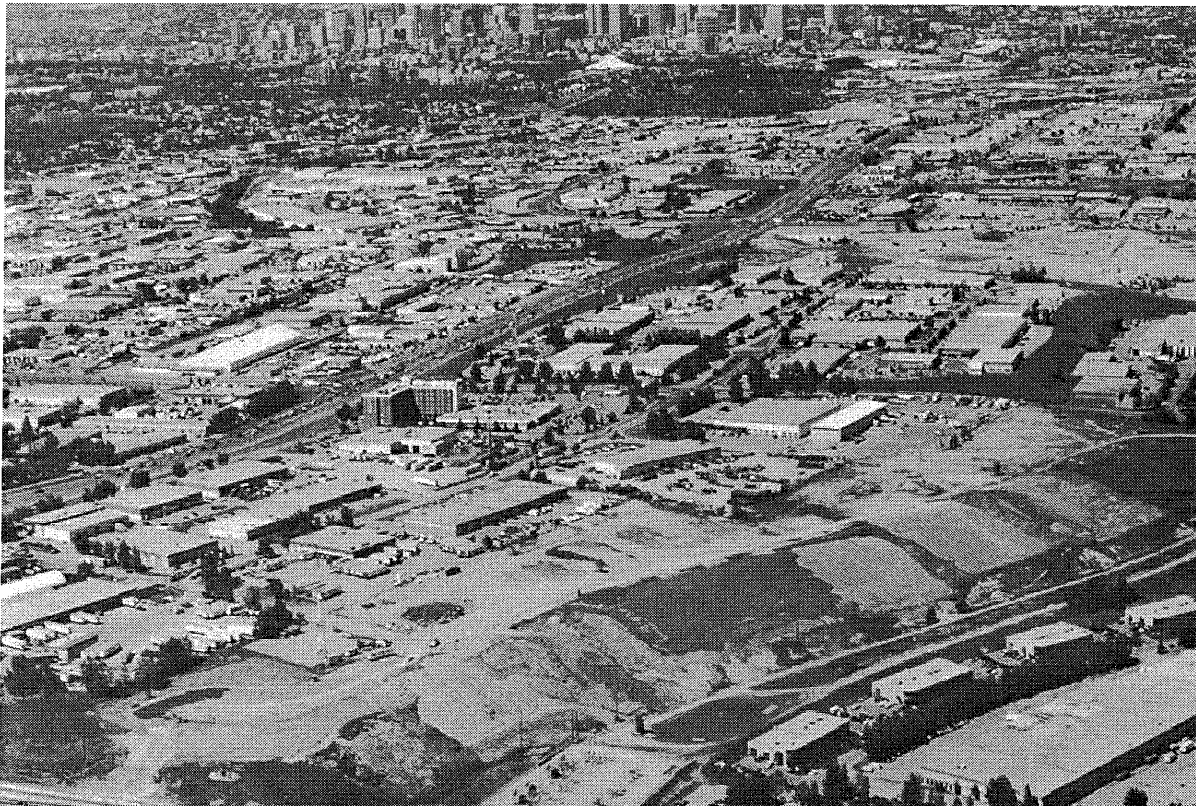
Fig. 7. Aerial photograph taken during construction of the upgraded landfill cover. Note panel construction method and close proximity of commercial development.
