# **PEAT - The Vancouver Experience**

Sheri Plewes, P.Eng., Phil Karlsson, A.S.T. and Brian Willock, P.Eng.  
Engineering Department, City of Vancouver

## **ABSTRACT**

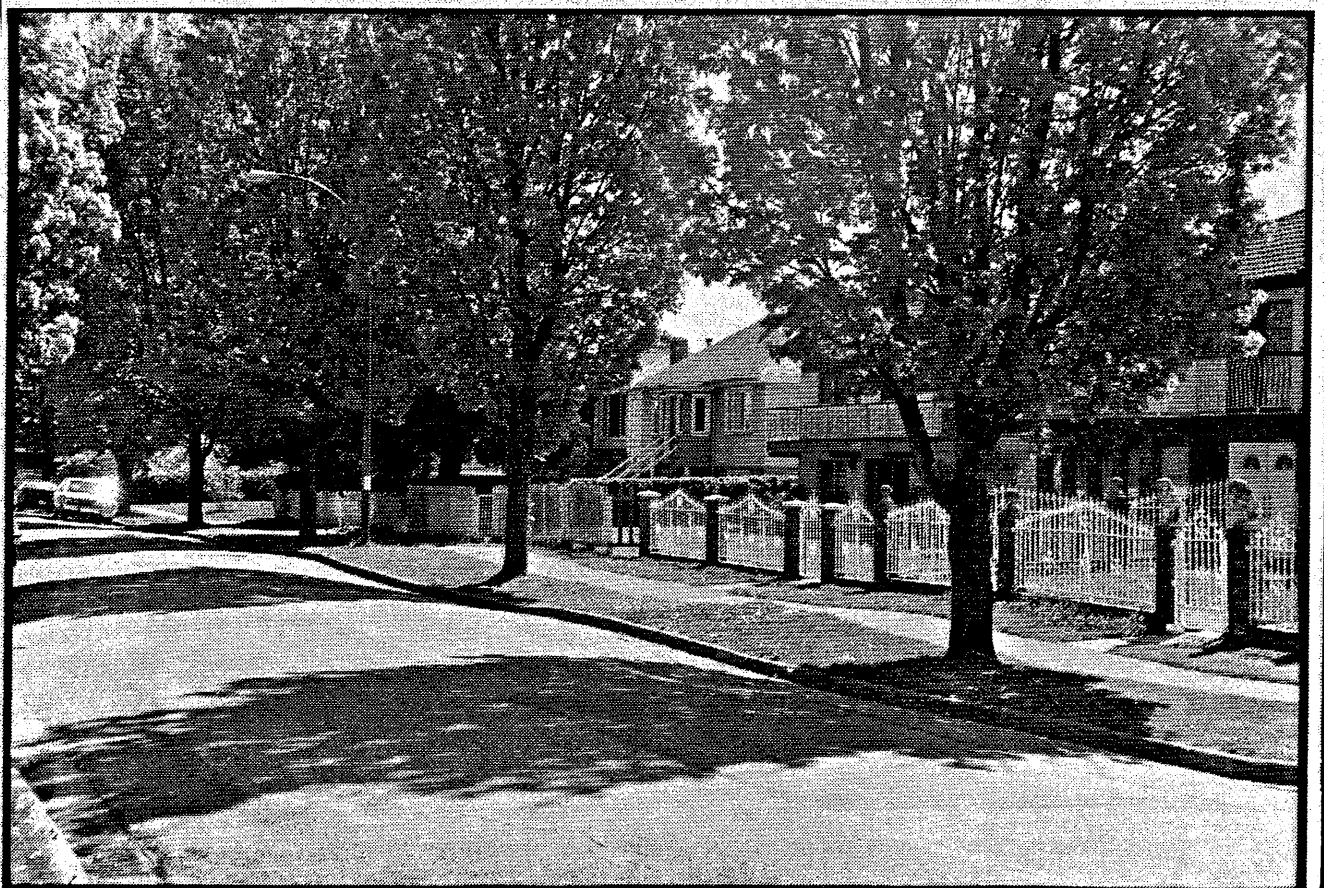
FIGURE 3: PHOTOS OF SETTLEMENT CAUSED BY LARGE TREES

Figure 3 shows similar observations with trees. As trees grow their root systems draw porewater out of a larger area of the peat, and the weight of the tree increases. These factors cause significant settlement around the tree which in turn causes

differential settlement below the curb and gutter, sidewalk, and pavement. Figure 3 shows some examples on 19th and 20th Avenues near Fraser Street. The result on narrow residential streets is poor drainage of surface water, as well as uneven surfaces for pedestrians and vehicles.

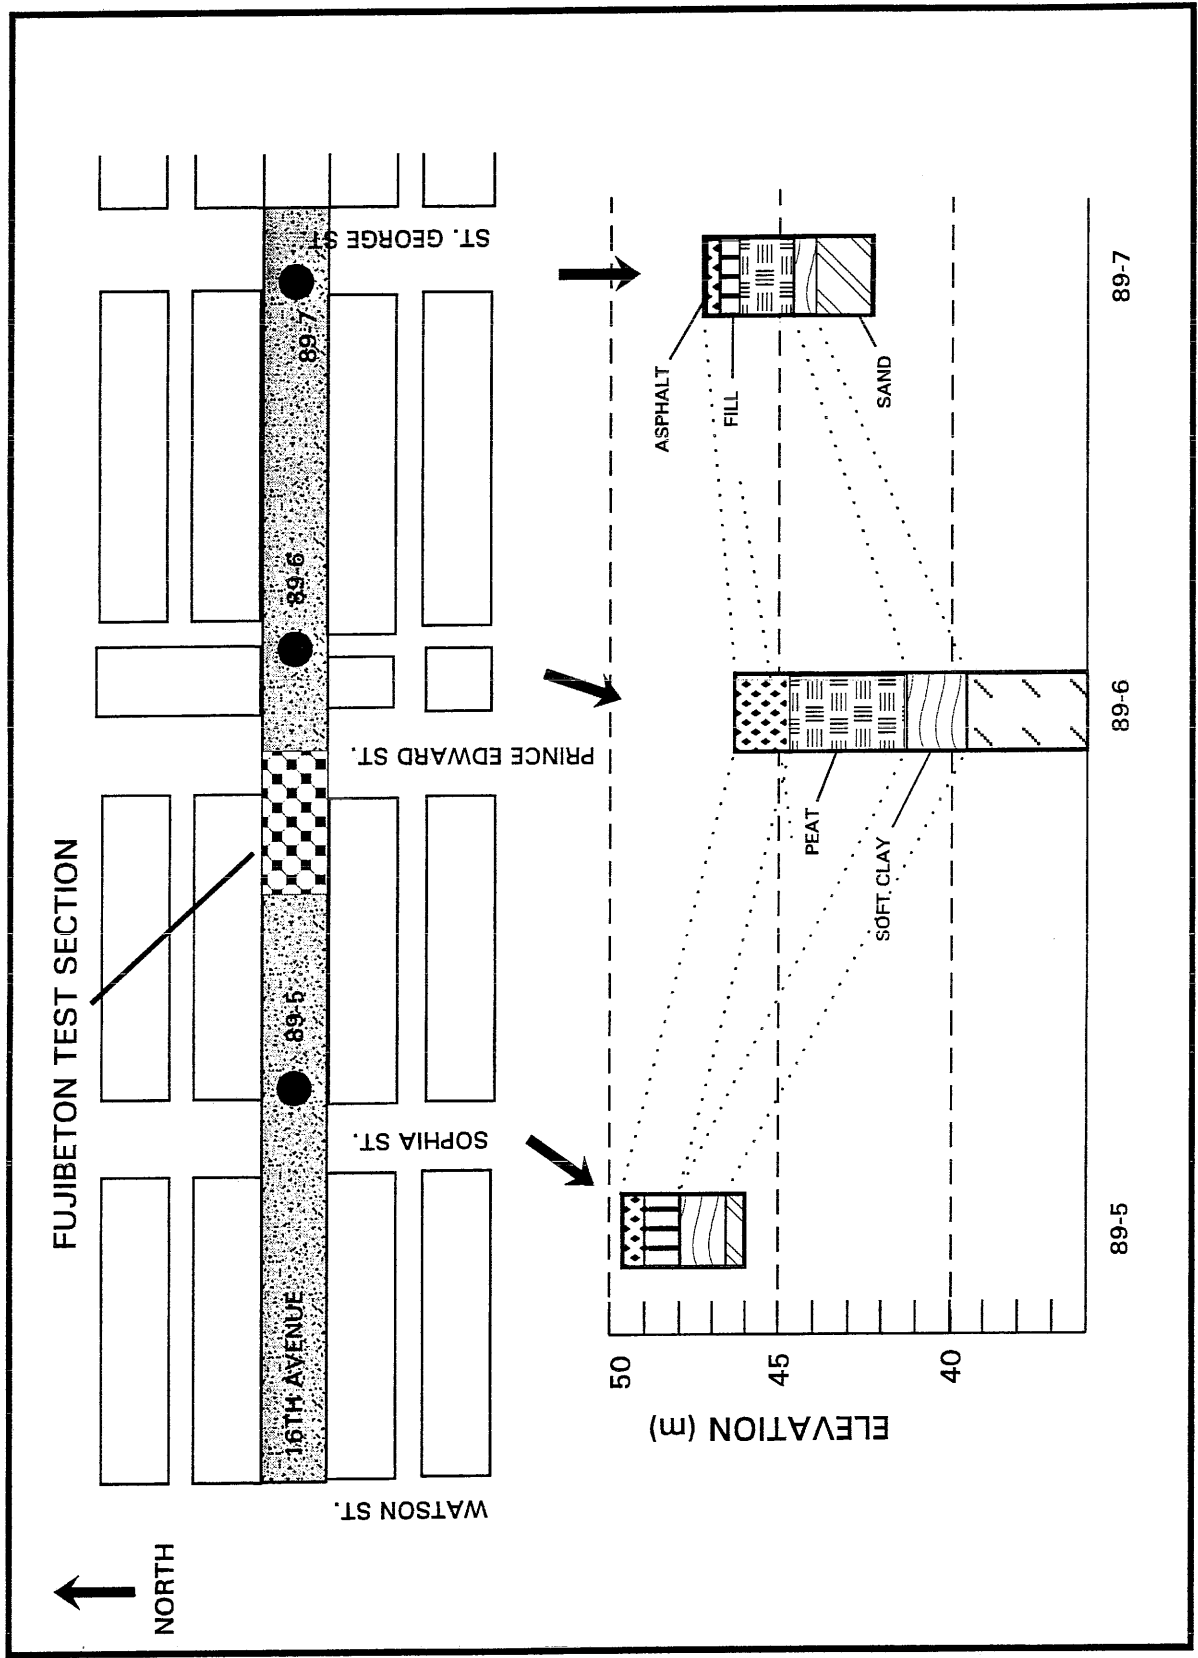
FIGURE 6: LOCATION OF RECONSTRUCTION AND PROFILE OF 16TH AVENUE

A test section on 16th Avenue, from the west side of Prince Edward Street extending one third of a block towards Sophia Street, was selected to evaluate the use of Fujibeton grout to stabilize thick peat deposits. Figure 6 shows the location of the test section and the soil profile of the area. Differential settlement in this area had resulted in damage to the street infrastructure.

The test section was located on 16th Avenue starting at the west side of Prince Edward Street and extending for approximately one third of a block west towards Sophia Street. Figure 6 shows the plan and soil profile of the test section. The full 11 m width of the street was grouted. This location was selected for the soil stabilization process because the underlying stratigraphy contains a substantial layer of peat. A more detailed description of 16th Avenue is contained in the subsequent description of the reconstruction of this street.

This case study documents the reconstruction of the concrete curb and gutter, sidewalk and asphalt concrete pavement on 16th Avenue from Watson Street to St. George Street. The project limits are shown on Figure 6.

The underlying stratigraphy at this location contains a significant layer of peat. Borehole logs showed that the peat layer was absent at Sophia Street and increased to a maximum depth of 4.5 m at Prince Edward Street. Figure 6 shows the profile of 16th Avenue from Sophia Street to St. George Street.
