TWITCHELL ISLAND LEVEE IMPROVEMENTS, NORTHERN CALIFORNIA DELTA AREA

Richard C. Sisson¹ and Fred N. Brovold²

Abstract

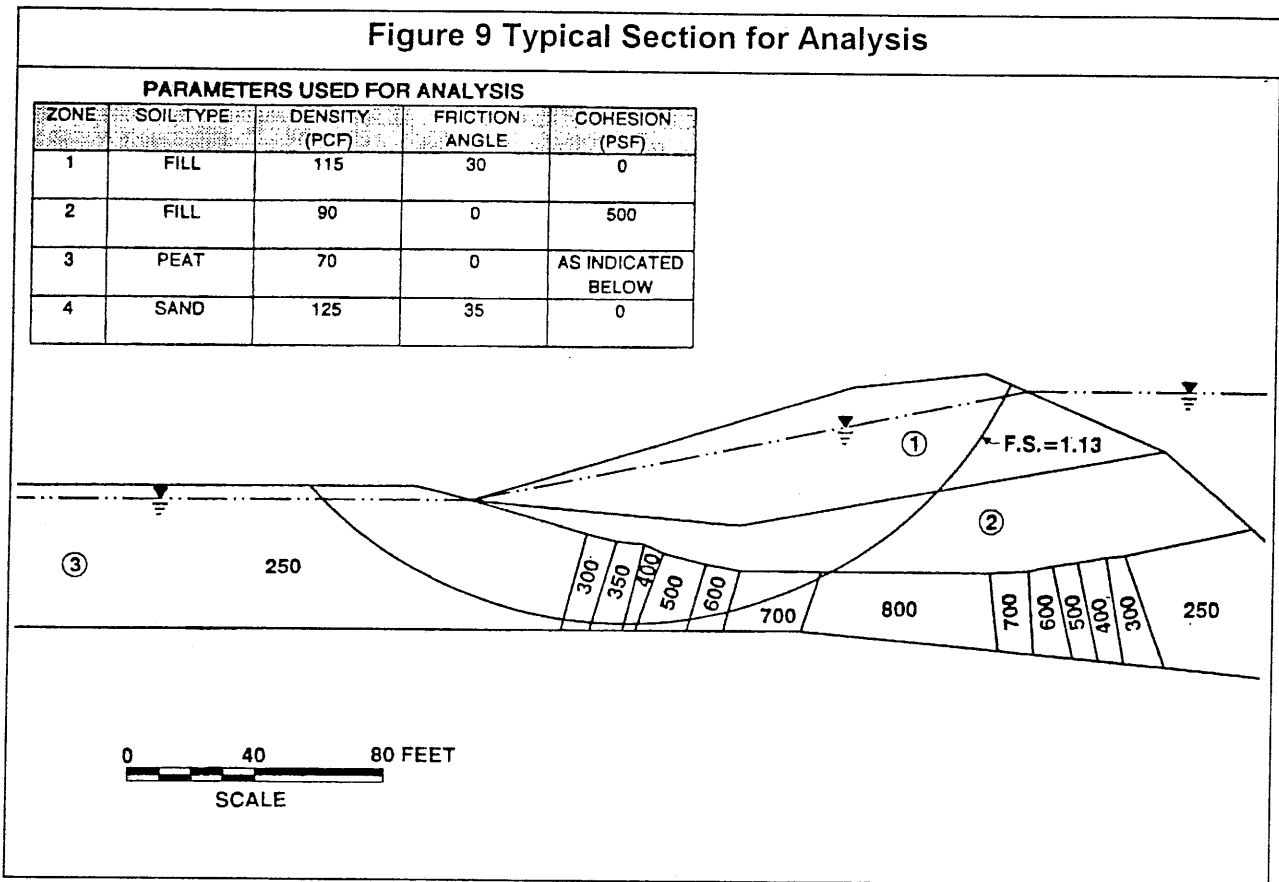
Figure 9 Typical Section for Analysis

SHANSEP method described above. A typical cross-sections showing the parameters used for analysis is shown in Figure 9.

The factors of safety determined in the analyses ranged from 1.06 to 1.40. The factor of safety correlated with the size of the toe berm and the elevation of the landside toe. When the importance of the toe berm configuration became apparent, a parametric study was performed to investigate the effect of berm size on levee stability. Several thicknesses and widths of berm were studied, with the potential strength gain and predicted settlement taken into account.

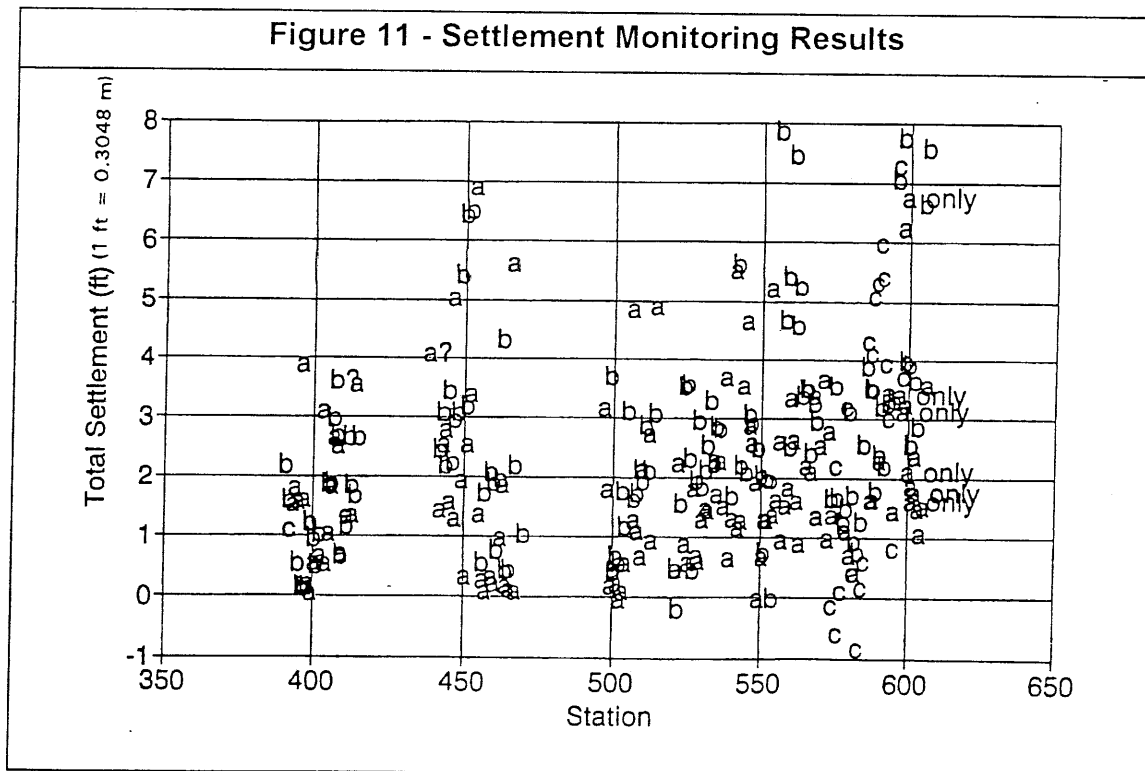
Settlements under the berm result from both consolidation and secondary compression. Settlements along the toe berm were relatively large. A plot of total settlements recorded along the berm is shown in Figure 11. The values range as high as 2.1 m. The average settlement measured at the A plates, nearest the levee, was 580 mm. The average settlement at the B plates was 790 mm, and the average settlement at the C plate was 730 mm.

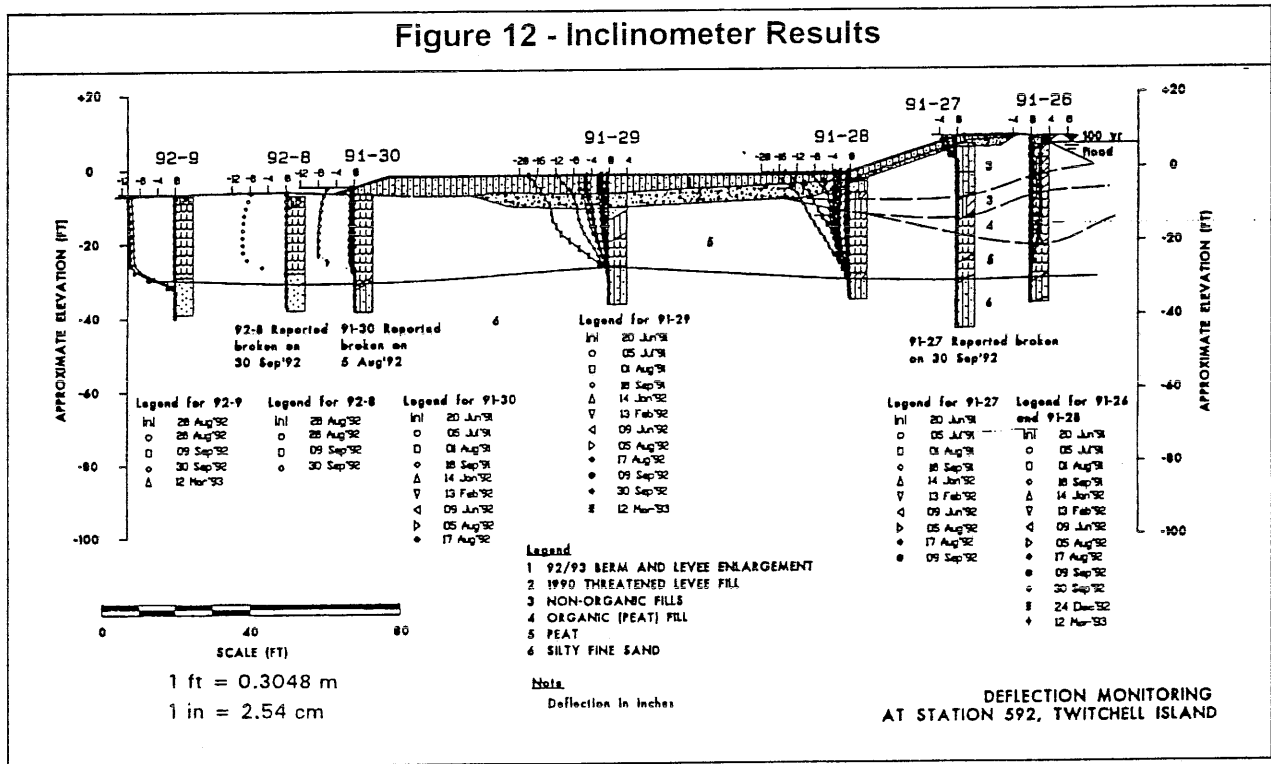
Inclinometers were used to measure lateral deformation at the project site. The results of monitoring at one of the most extensive arrays is shown on Figure 12. The inclinometers indicate relatively small deformations (less than 100 mm) beneath the crown, with deformations so large (in excess of 300 mm) that inclinometers at the toe of the berm were rendered inoperable by the deformation. In addition, deformation patterns at the toe of the berm typically showed concentrated displacement at the base

of the peat, while deformations patterns under the middle of the berm indicated relatively uniform strain increasing with time.
